Hyundai: Tucson/ix35 : 2020- (NX/NX4e/NX4i): Front Wheel Drive

Work Order: R000002
Last Name: Jones
First Name: Alan
Street: 2589 Canyon Rd
City: St. Louis
State: MO
ZIP: 63128
EMAIL: ajones@charter.com
Home Tel.: 636-478-9632
Work Tel.: 314-458-9856
VIN: 1YVHP80C985M28066
License: BDF-012
Year: 08
Technician: Bill
Mileage: 33986
Date: 6/1/09 4:16 PM

Volkswagen : Golf (Including Variant, Cabrio) : Golf VIII
2024- (DA/DB) : with Independent Rear Suspension :
Standard Suspension (G01 G04 G12 G22 G23)

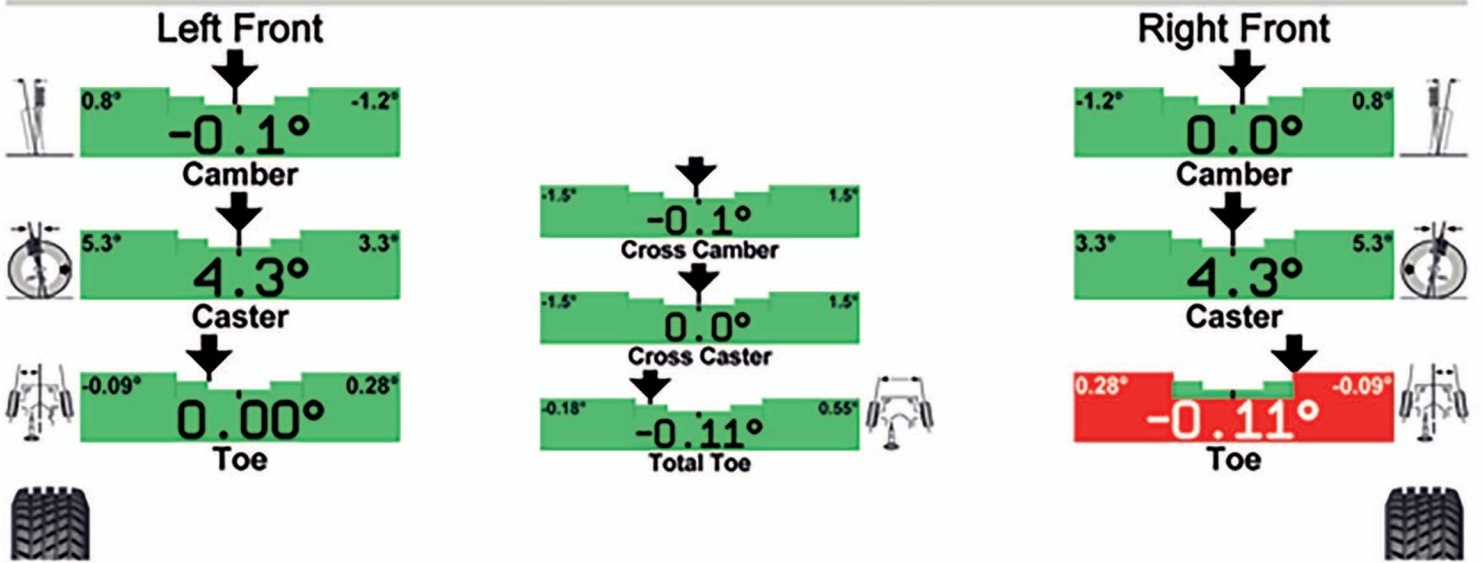
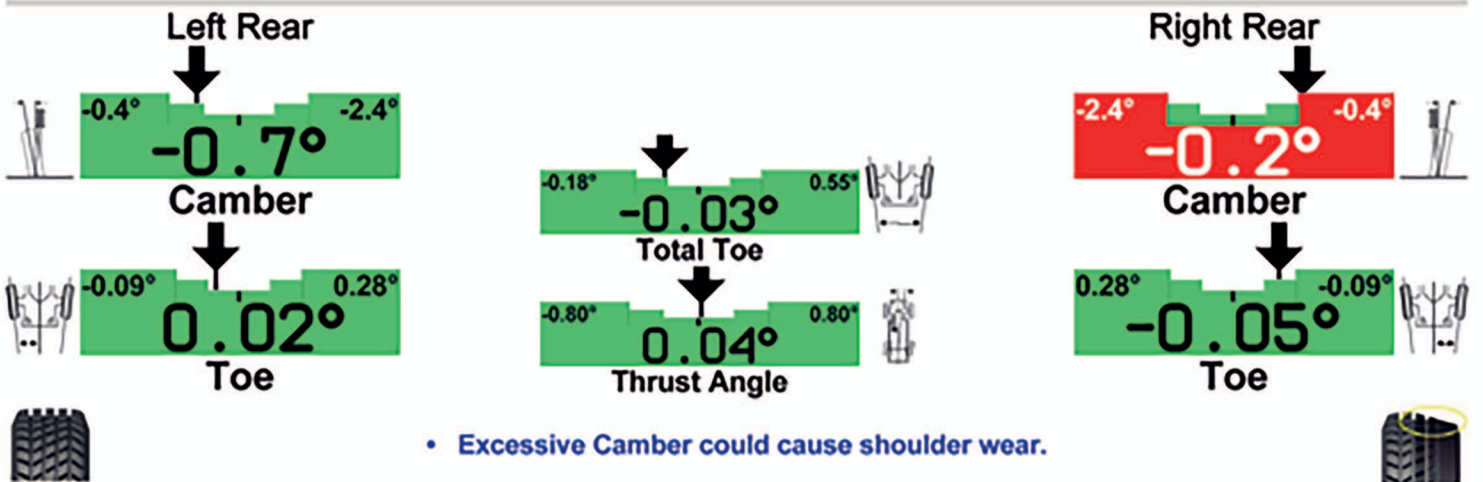
Before Measurements

• Excessive Camber could cause shoulder wear.

• The steering wheel was level before the alignment.
